Wohl Coatings Inc.

REPAIR BROKEN AND CRACKED CONCRETE

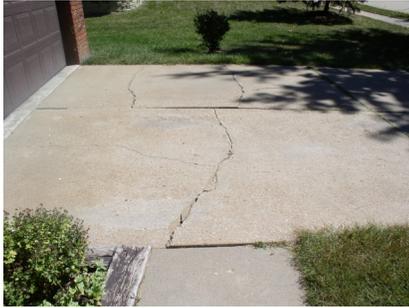
Picture 1 Large deep cracks on upper two slabs. Crack closest to sidewalk has considerable height difference. Picture 2 Large cracks in both left and right slabs.

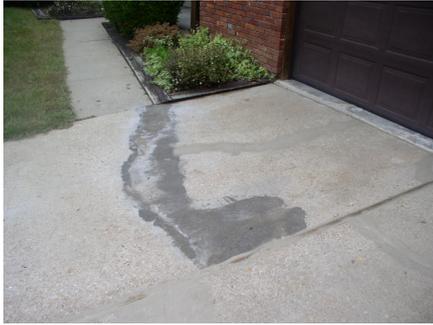
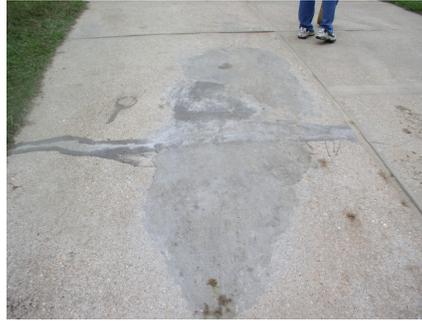
Cracked slabs brought up to level and repaired with ShurBond 550 Epoxy Adhesive and ShurBond 100 Polymer Concrete. Picture on the right also shows severely spalled area
